Your Inspection Report

148 Rickson Ave
Guelph, ON N1G4B2

Wednesday, November 10, 2010

RE: Report No. 1006, v.3
148 Rickson Ave
Guelph, ON
N1G4B2

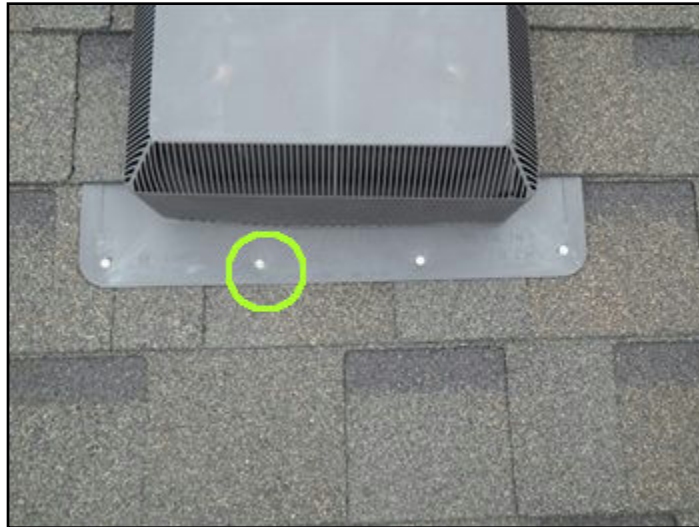
1. Condition: • [Exposed fasteners](#)

Exposed fasteners at all roof penetrations. Recommend caulking to prevent water penetration into the home.

Implication(s): Chance of water damage to contents, finishes and/or structure

Location: Throughout Roof

Task: Improve

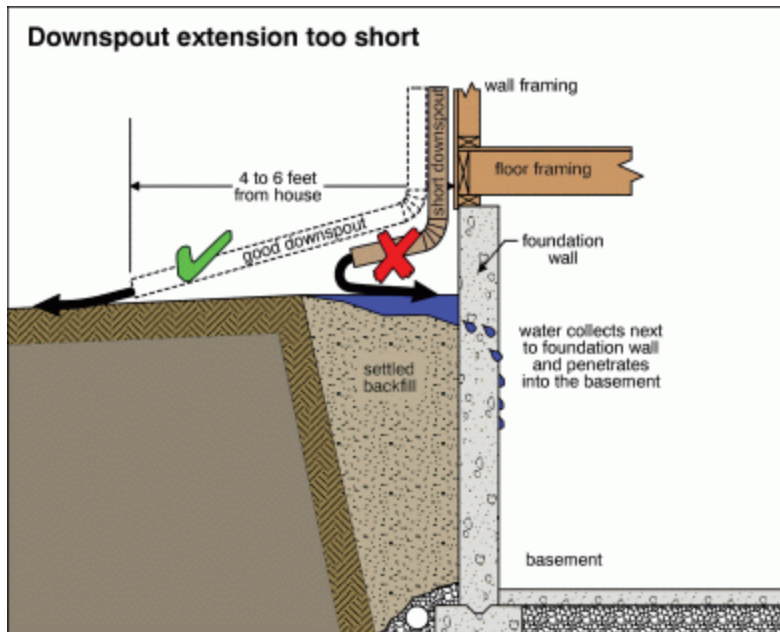
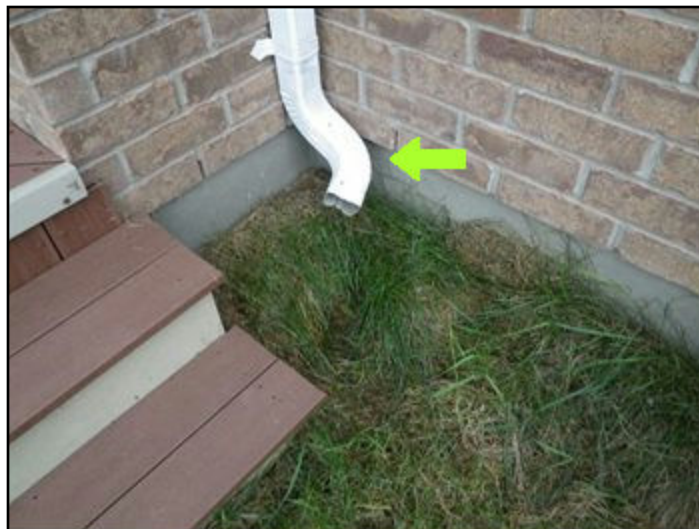
2. Condition: • [Downspouts end too close to building](#)

Implication(s): Chance of water damage to contents, finishes and/or structure

Location: West Exterior

All downspout's need to be extended away from the home by a minimum of 6 feet.

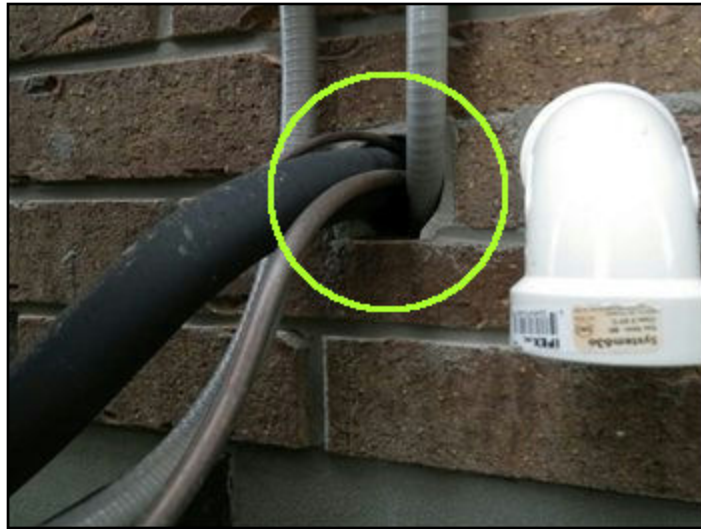
3. Condition: • [Caulking missing or ineffective](#)

Exterior wall penetrations for Air Conditioner supply lines need to be caulked to prevent moisture and rodents from entering the home.

Implication(s): Chance of water damage to contents, finishes and/or structure

Location: South Exterior Wall

Task: Repair

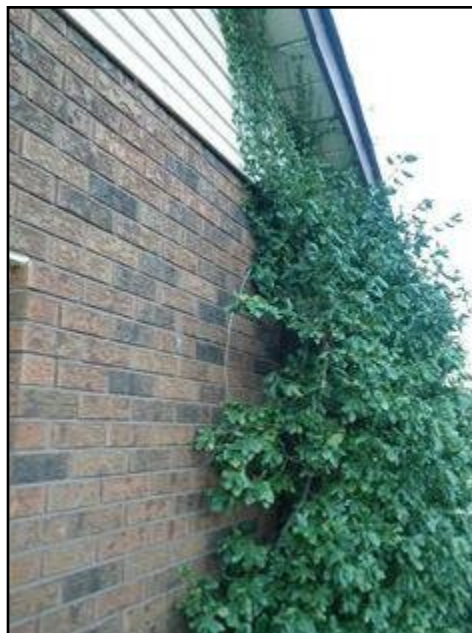
4. Condition: • [Vines](#)

Vines growing on east side of home can damage finishes and shorten the life of exterior wall cladding.

Implication(s): Chance of damage to finishes

Location: East Exterior

Task: Remove

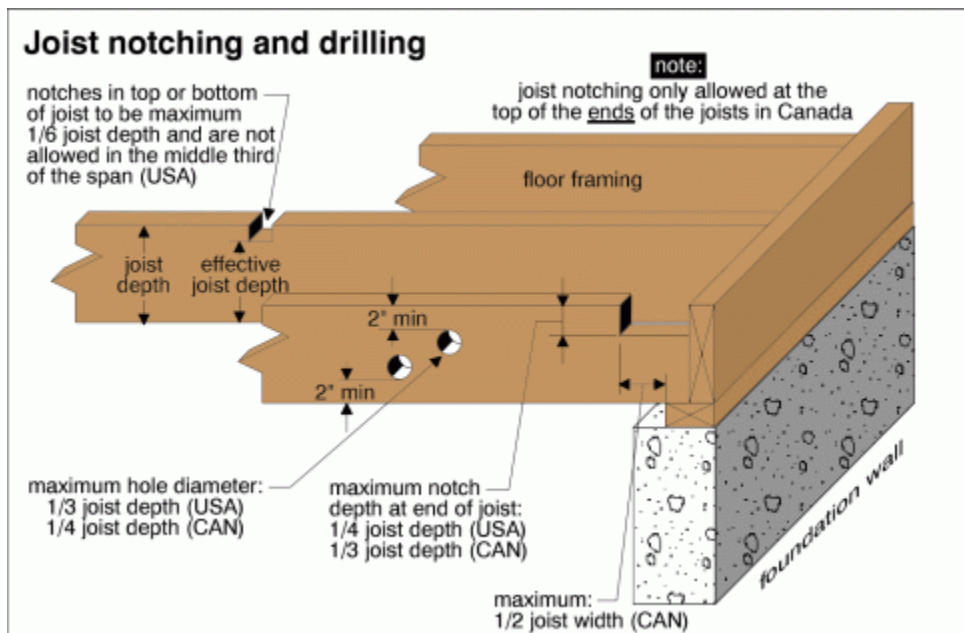
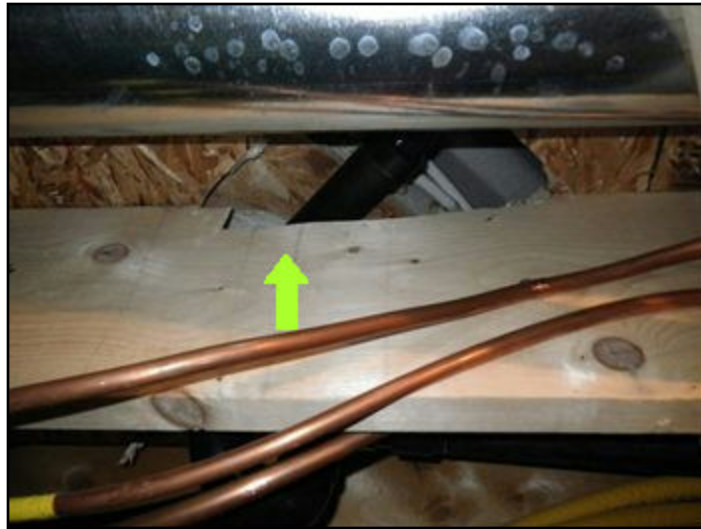
Condition: • [Notches or holes](#)

Main floor joists which provide structural support for the floor system notched to provide space for plumbing in mechanical room.

5. Condition: • [Notches or holes](#)

Implication(s): Weakened structure

Location: South Basement Utility Room

Task: Repair

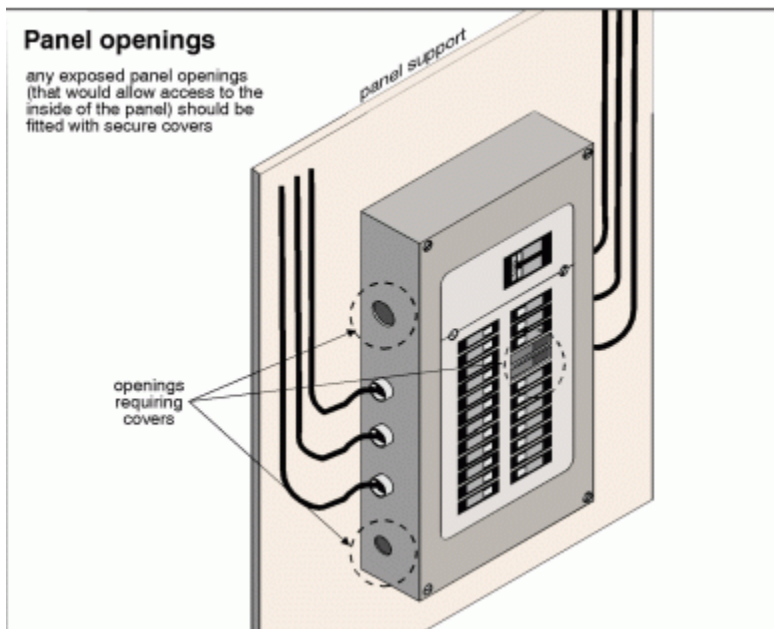
6. Condition: • [Openings in panel](#)

Opening in electrical distribution panel cover needs to be repaired immediately as it is a safety concern.

Implication(s): Electric shock | Fire hazard

Location: East Basement

Task: Provide

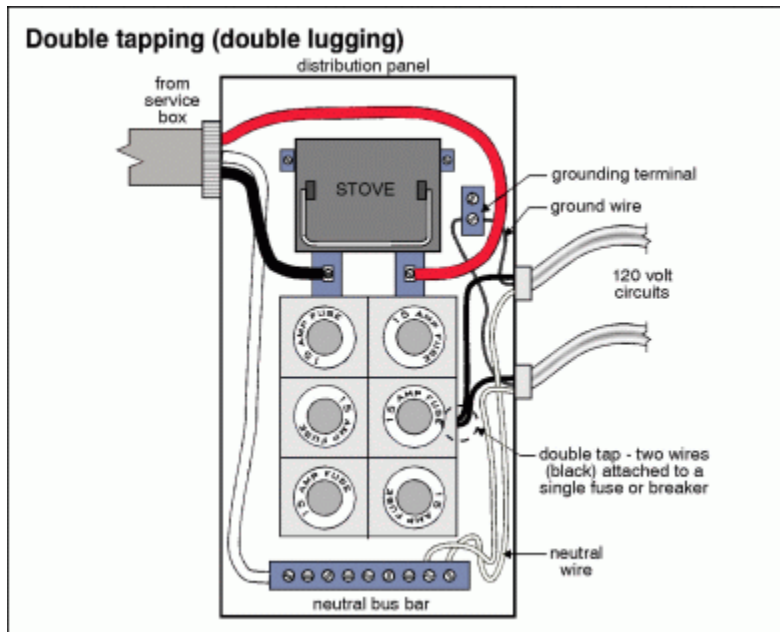
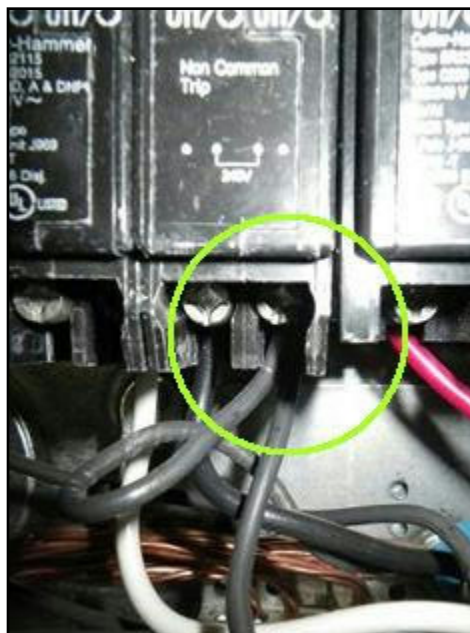
6.

Condition: • [Double taps](#)

In the electrical distribution panel, two wires are attached to a single breaker. Most terminals are not designed to accommodate two wires. The risk of a poor connection is greater with double taps.

7. Condition: • [Double taps](#)

Implication(s): Fire hazard

Location: East Basement

Task: Repair

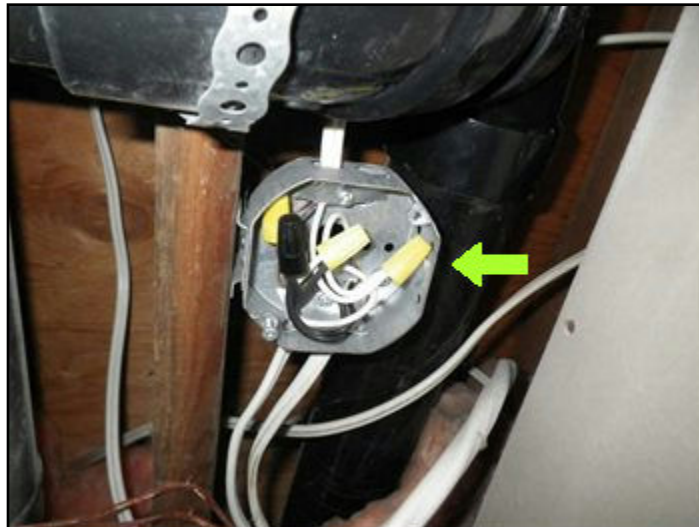
7.

Condition: • [Cover loose or missing](#)

In the basement utility room above the furnace and electrical junction box is missing its cover.

8. Condition: • [Cover loose or missing](#)

Implication(s): Electric shock | Fire hazard

Location: West Basement Utility Room

Task: Provide

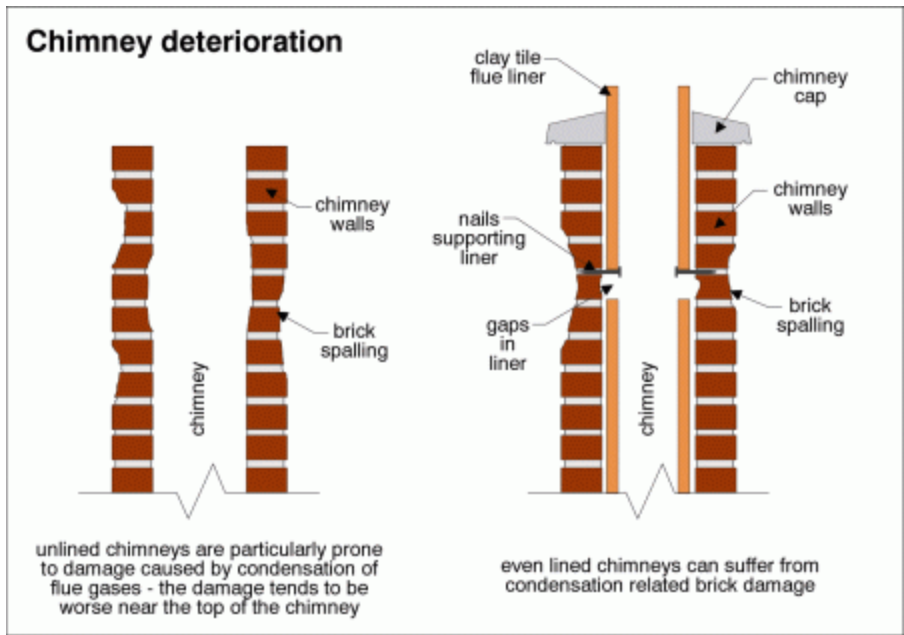
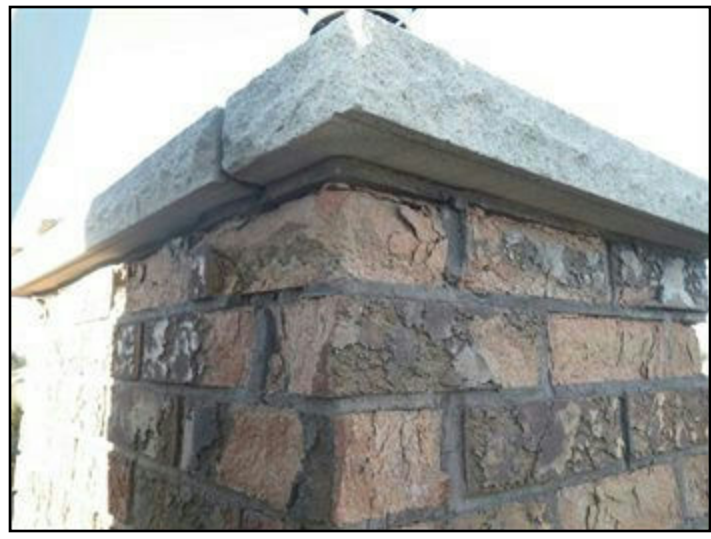
8.

Condition: • [Spalling](#)

The chimney which provides venting for the wood burning fireplace in the living room requires rebuilding of its top 10 rows of bricks. The bricks have begun spalling which is a common occurrence for a chimney of this age and construction.

9. Condition: • [Spalling](#)

Implication(s): Material deterioration

Location: East Exterior

Task: Repair

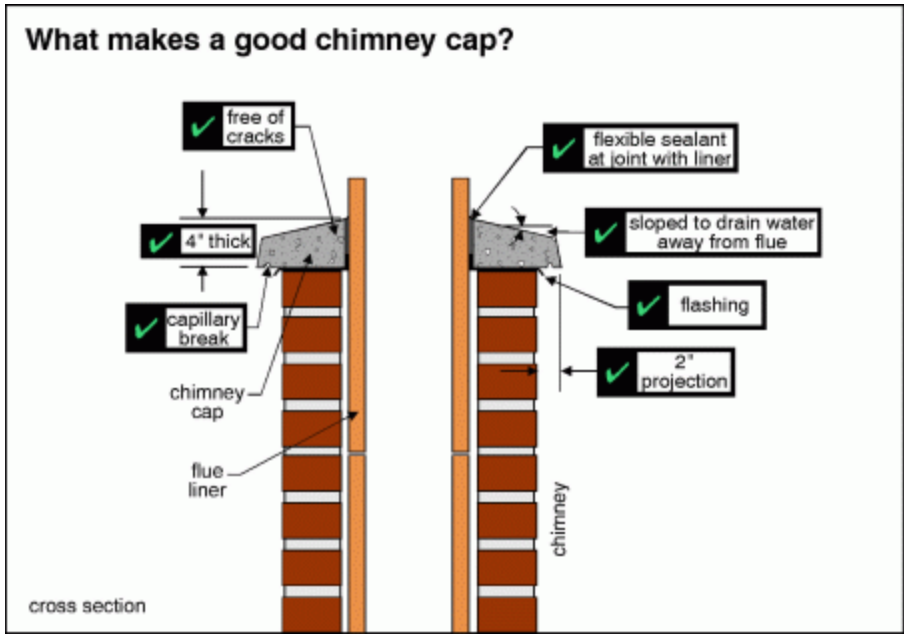
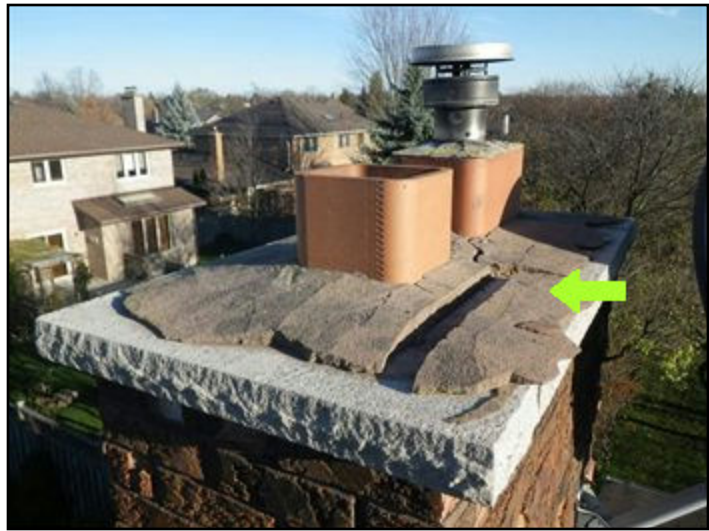
9.

10. Condition: • [Cracked](#)

The chimney cap, which provides weather protection for the flues, has cracked and needs to be repaired.

Implication(s): Chance of water damage to contents, finishes and/or structure | Shortened life expectancy of material

Location: East Exterior

Task: Repair

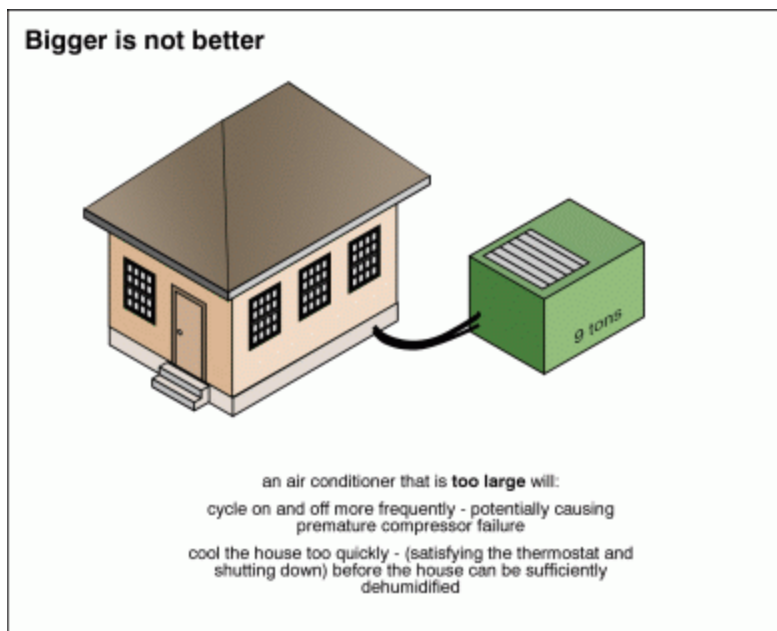
11. Condition: • [Possibly oversized](#)

Implication(s): Reduced system life expectancy | Increased cooling costs | Reduced comfort

Location: South Exterior

Task: Monitor

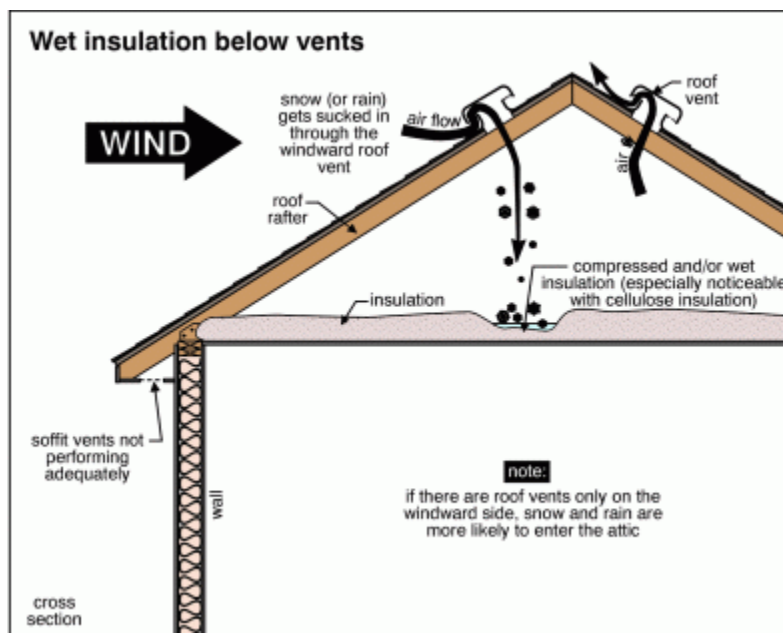
Condition: • [Compressed](#)

Attic insulation has compressed overtime reducing its performance. Recommend blowing in loose fill insulation to increase its R-value and reducing heating and cooling costs.

12. Condition: • [Compressed](#)

Implication(s): Increased heating and cooling costs | Reduced comfort

Location: Throughout Attic

Task: Provide

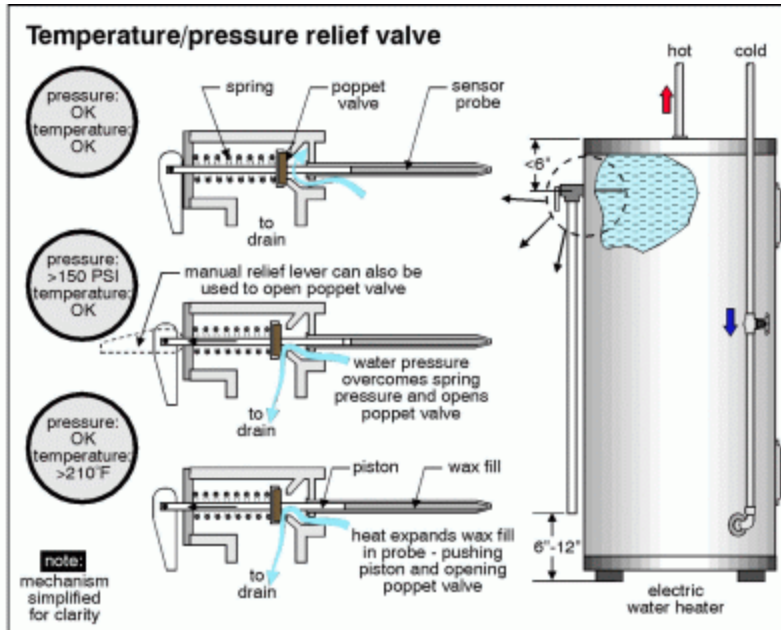
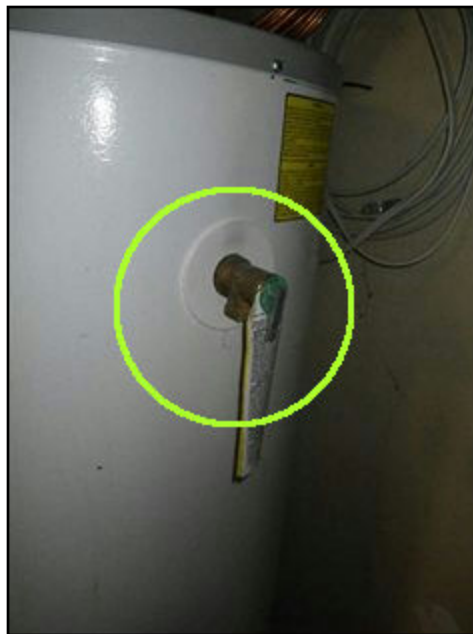
10.

Condition: • [Discharge tube missing](#)

Discharge tube for pressure release valve missing from hot water heater. Recommend replacing immediately as this is a safety concern.

13. Condition: • [Discharge tube missing](#)

Implication(s): Scalding

Location: Basement Utility Room

Task: Repair

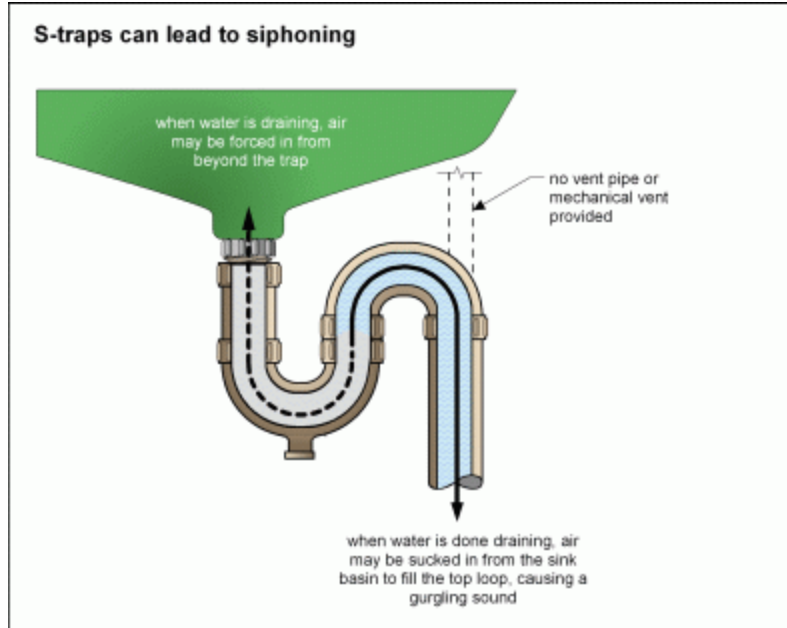
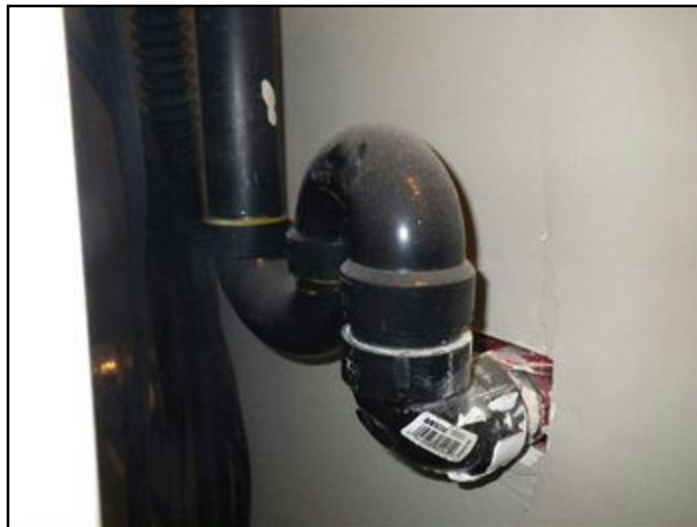
11.

Condition: • [Wrong type](#)

Waste plumbing for laundry equipment has a S-trap. The implication of an S-trap is siphoning of the water in the trap. This water is what stops sewer gases from entering the home. Recommend having a licensed plumber repair immediately.

14. Condition: • [Wrong type](#)

Implication(s): Sewer gases entering the house | Sewage entering the house

Location: North First Floor Laundry Area

Task: Repair
Time: Immediately
Cost: Minor

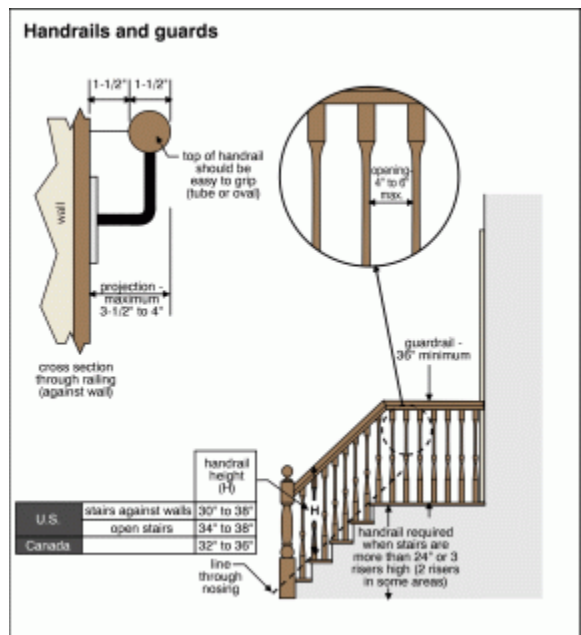
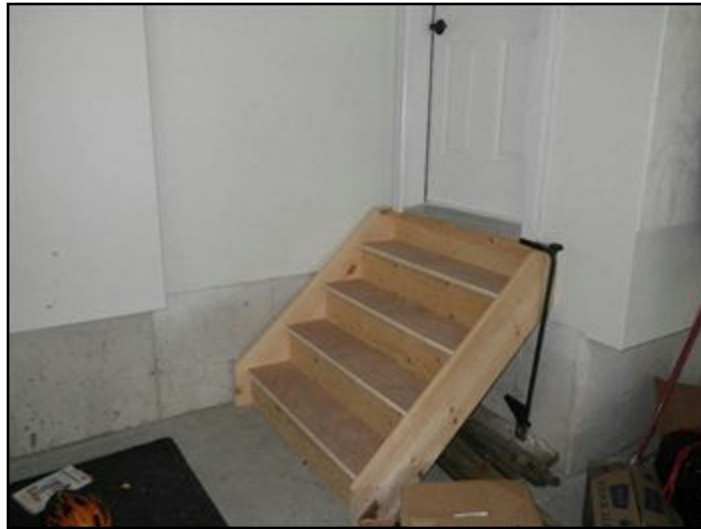
12.

Condition: • [Missing](#)

Stairs from garage to mud room have no handrail. Provide immediately as this is a safety concern.

15. Condition: • [Missing](#)

Implication(s): Fall hazard

Location: First Floor Garage

Task: Provide
